**PLIA Preliminary Planning Assessment  
Illahee Foods  
5507 Illahee Rd NE  
Bremerton, WA 98310**

**October 10, 2017  
G-Logics Project 01-1129-A  
Copyright 2017 G-Logics, Inc.  
All Rights Reserved**

**Subject: PLIA Preliminary Planning Assessment  
Illahee Foods  
5507 Illahee Rd NE  
Bremerton, WA 98310**

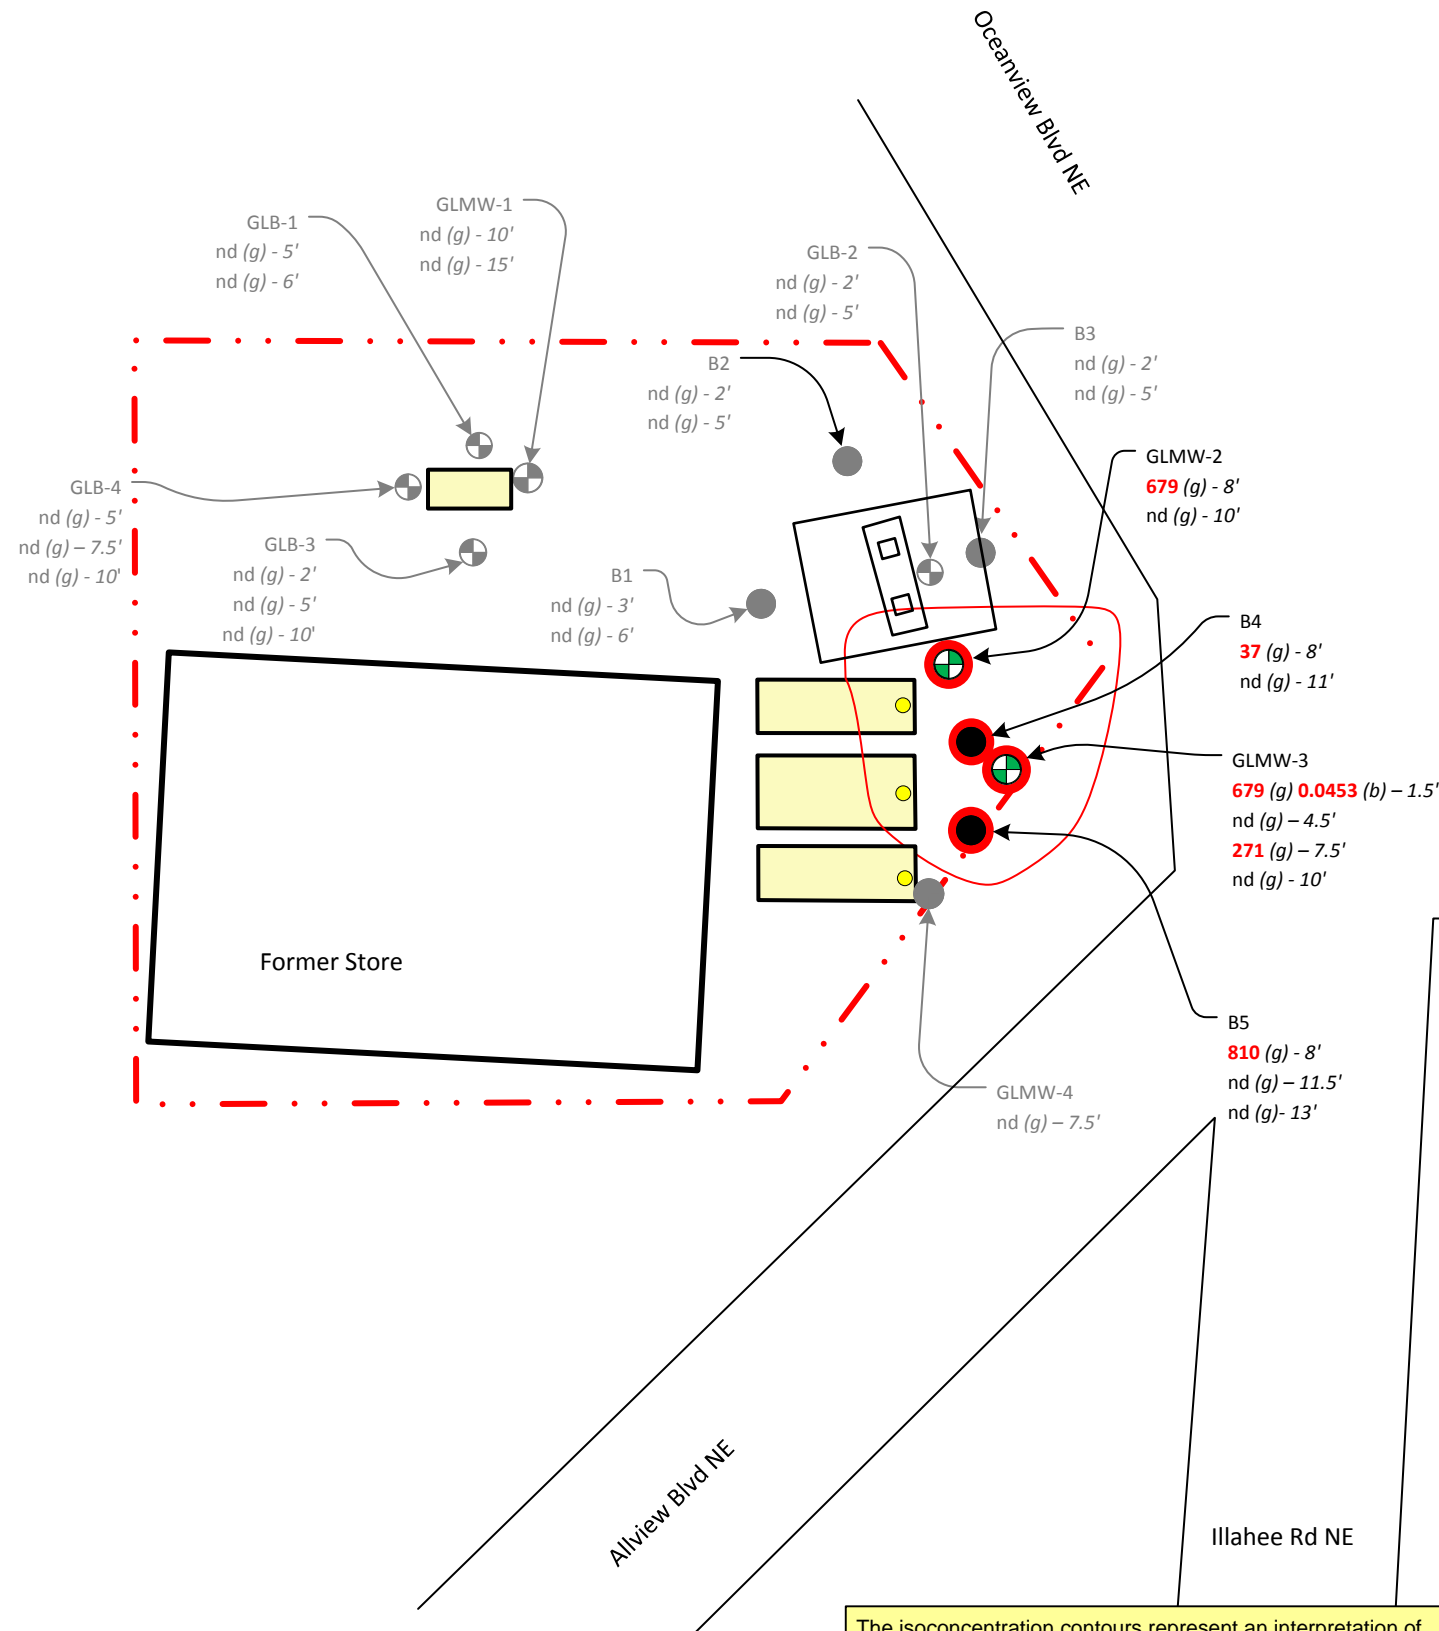
- Property Line
- Building Outline
- Approximate Area of Contamination
- Underground Storage Tanks
- Langseth Boring Locations
- GLMW-1
- G-Logics Monitoring Well Locations
- GLB-1
- G-Logics Boring Locations
- Contaminant Concentrations Detected Above MTCA Cleanup Level

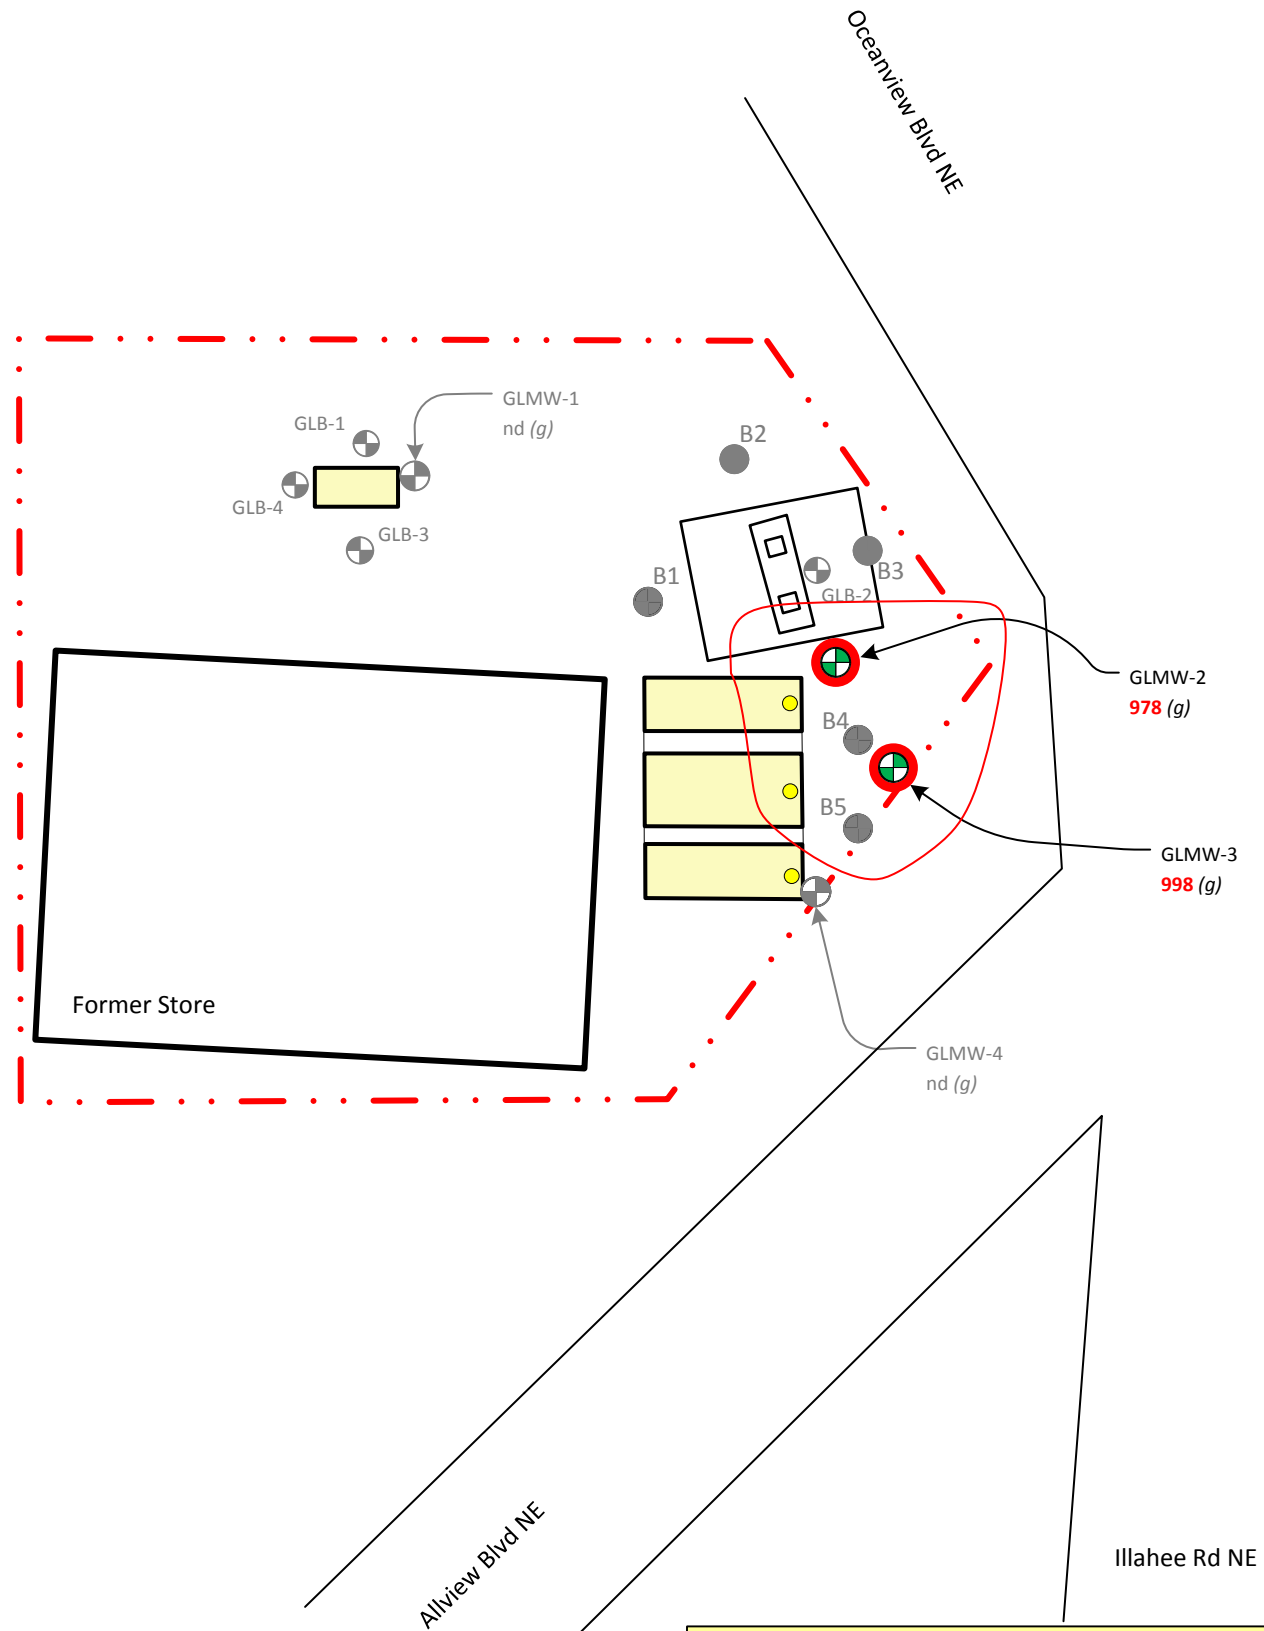
**Figure**  
**5**

- Property Line
- Building Outline
- Approximate Area of Contamination
- Underground Storage Tanks
- B4  
Langseth Boring Locations
- GLMW-1  
G-Logics Monitoring Well Locations
- GLB-1  
G-Logics Boring Locations
- 998  
Contaminant Concentrations Detected Above MTCA Cleanup Level

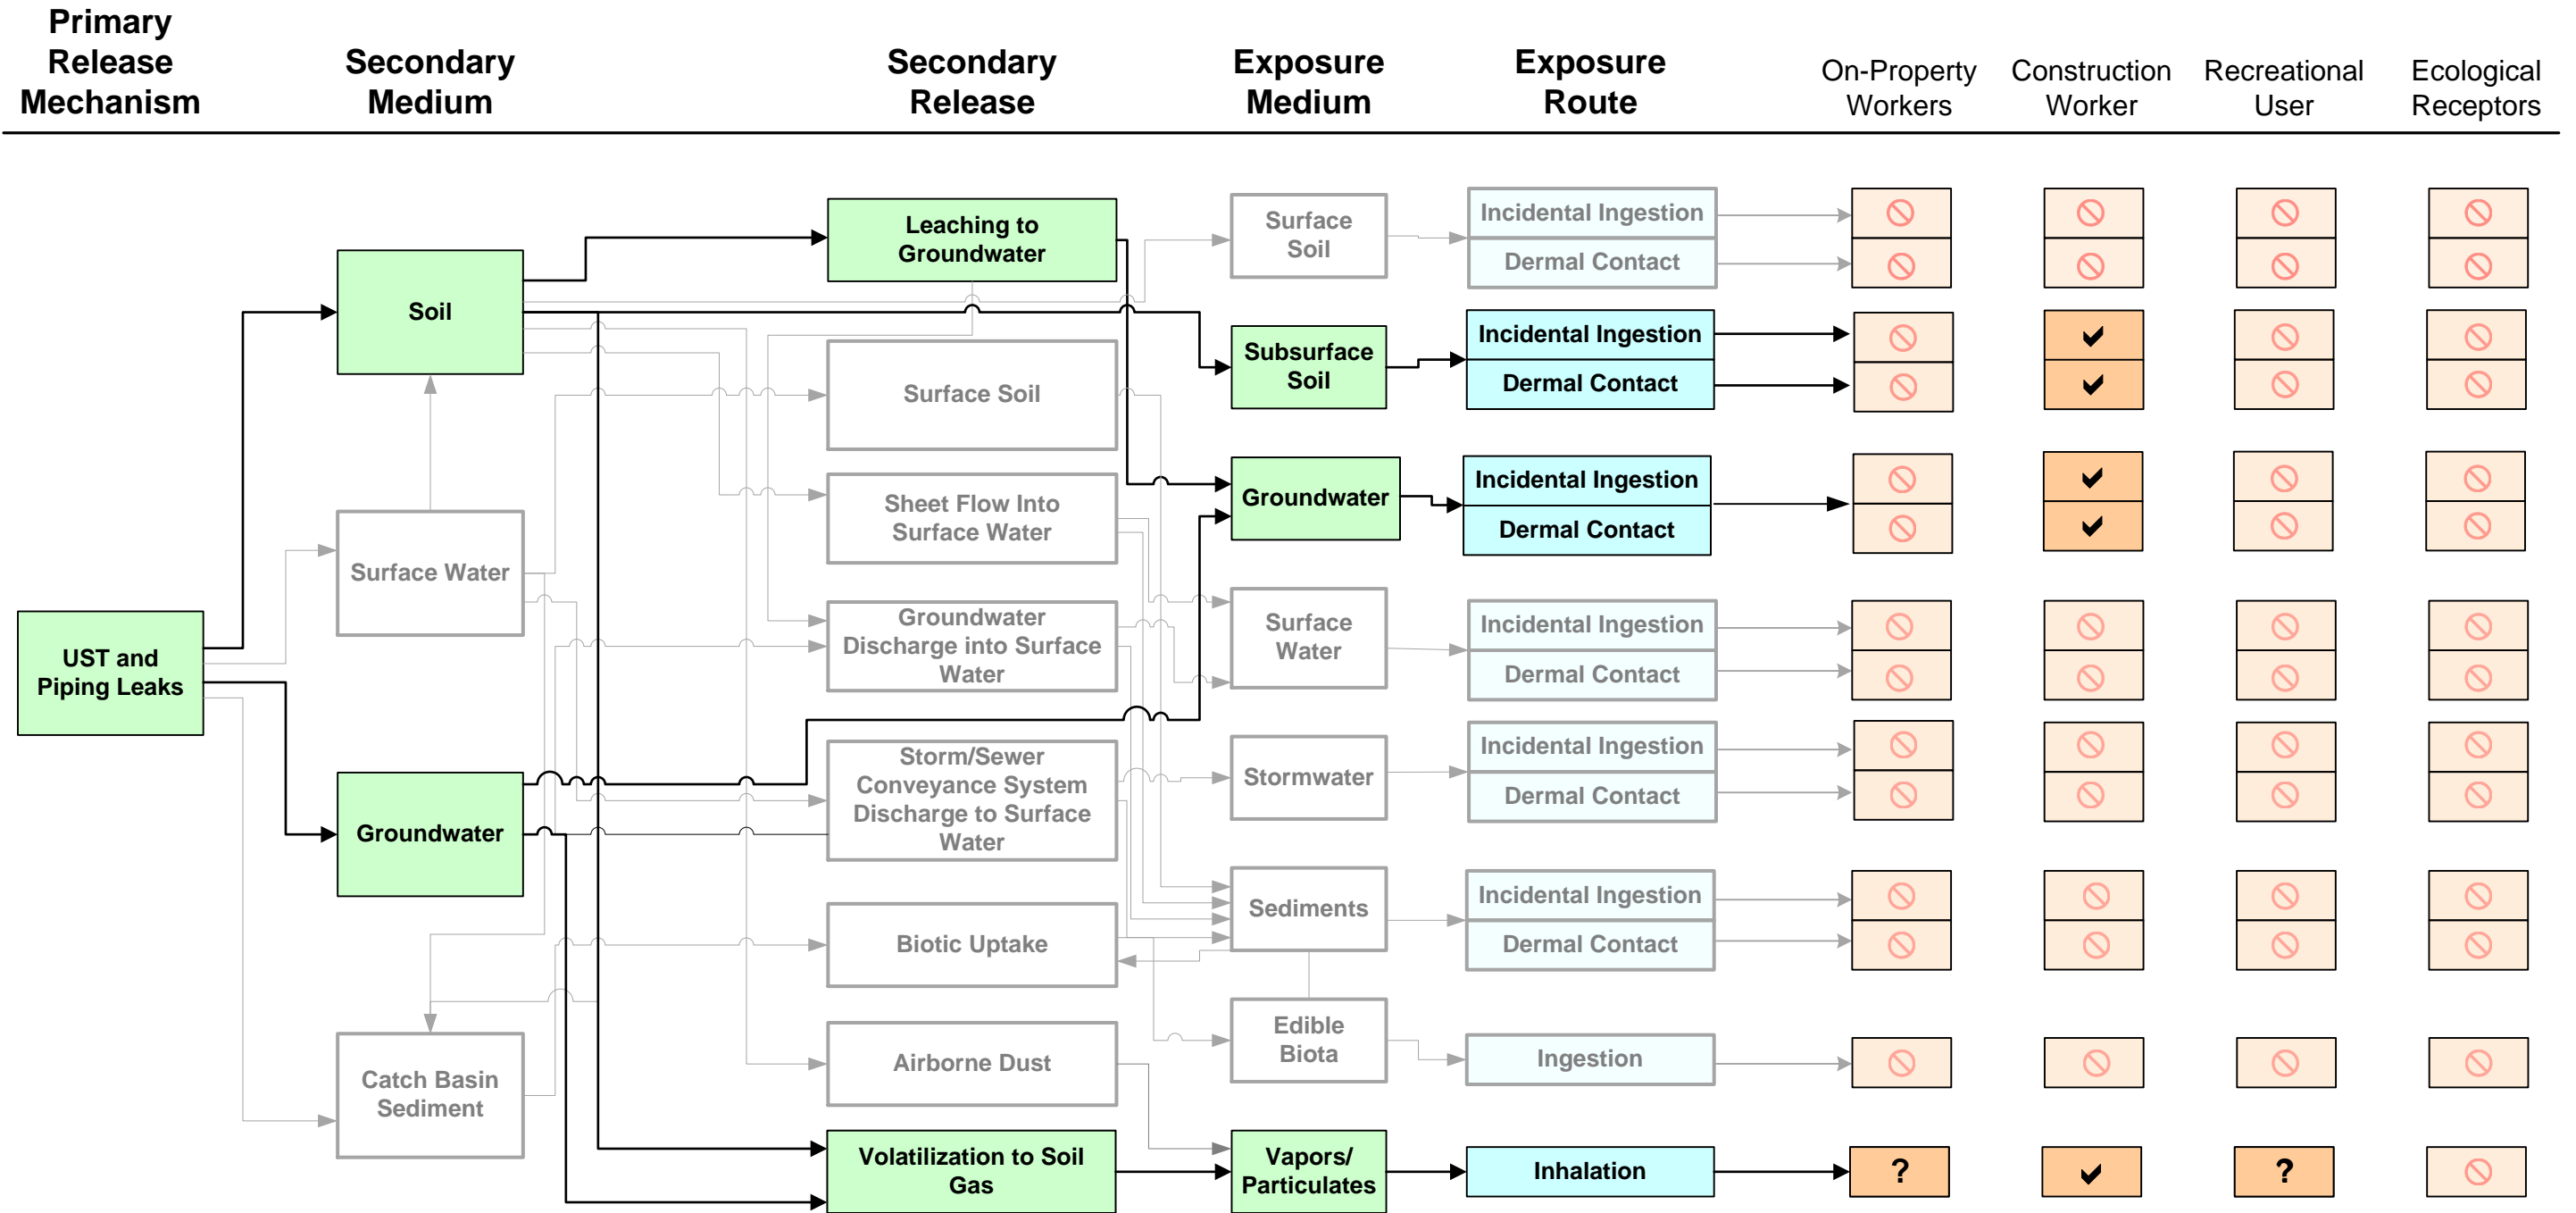
The following sections include discussion of the fate and transport of the hazardous substances, impacted media, potential exposure pathways, and possible receptors. The conceptual site model for this Site is illustrated on Figure 7.

- ✓ Complete exposure pathway
- ⊘ Incomplete exposure pathway
- ? Exposure pathway could be complete, but the potential receptor is unlikely

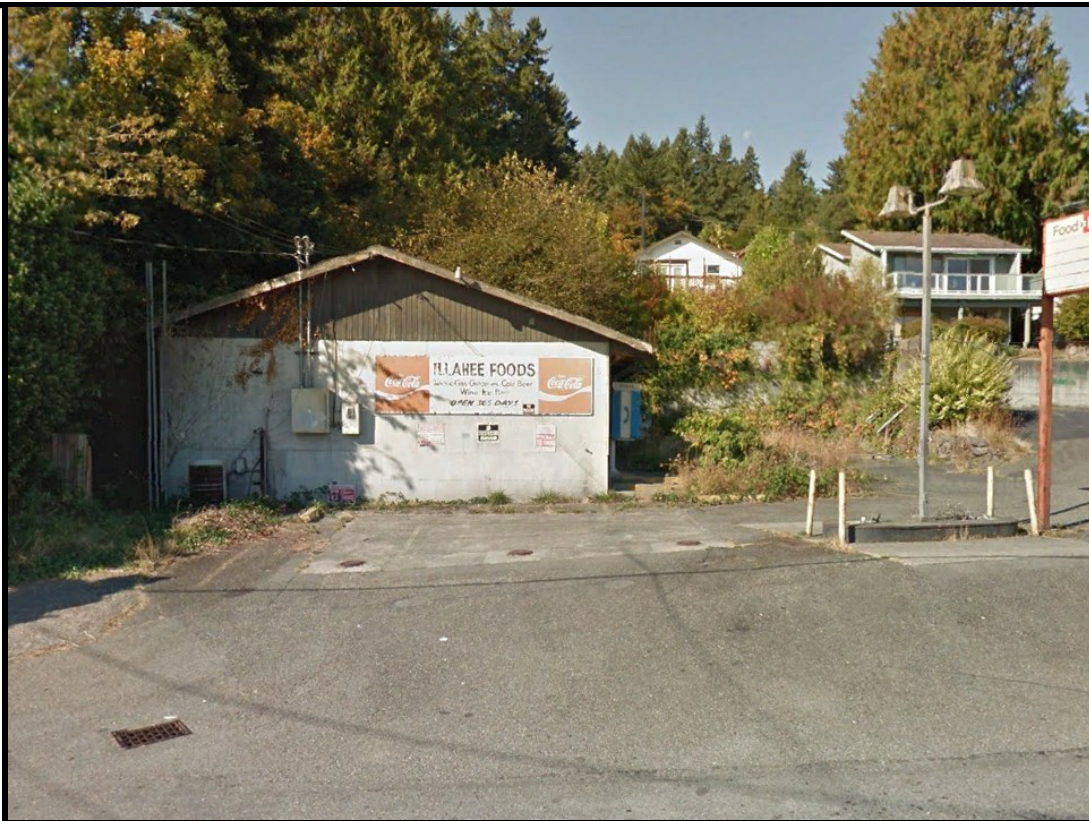
1

**Description:** Looking west at the Property.

**Comments:** Fill ports for USTs are visible in front of the building.

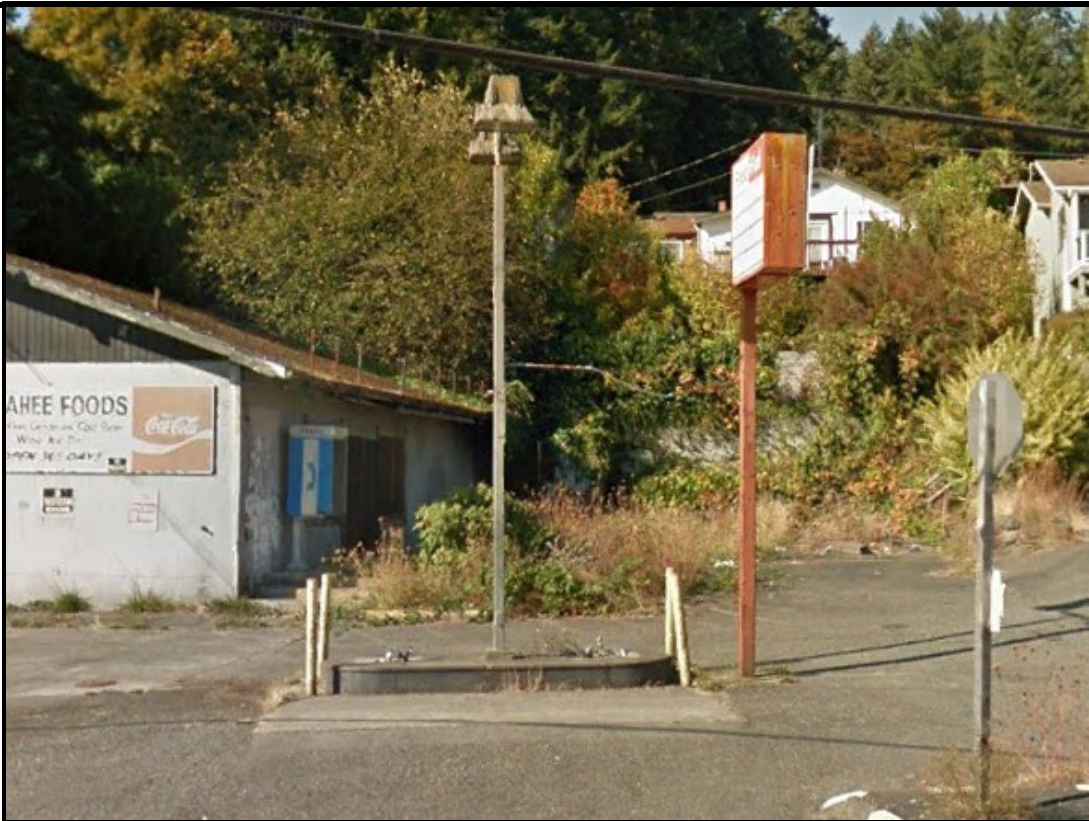
2

**Description:** Former pump island on eastern portion of the Property.

**Comments:** The former dispensers have been removed.

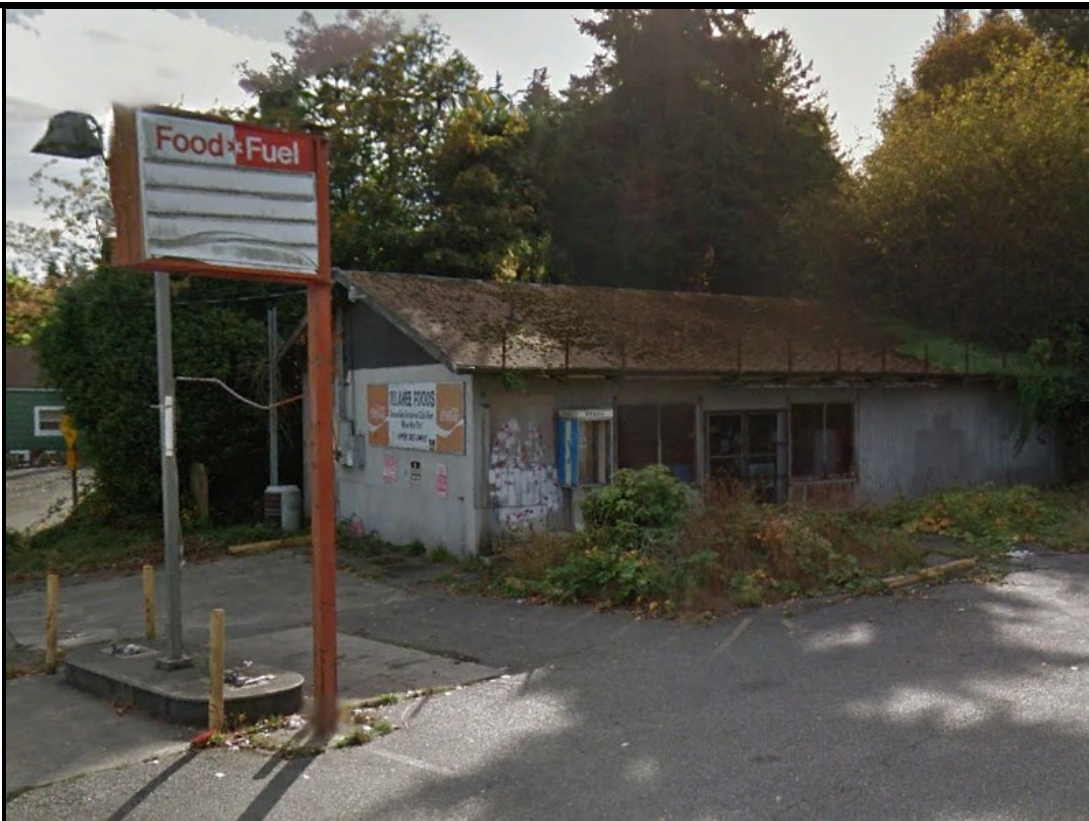
3

**Description:** Vacant store on the Property.

**Comments:** Property has been vacant since approximately 2003.

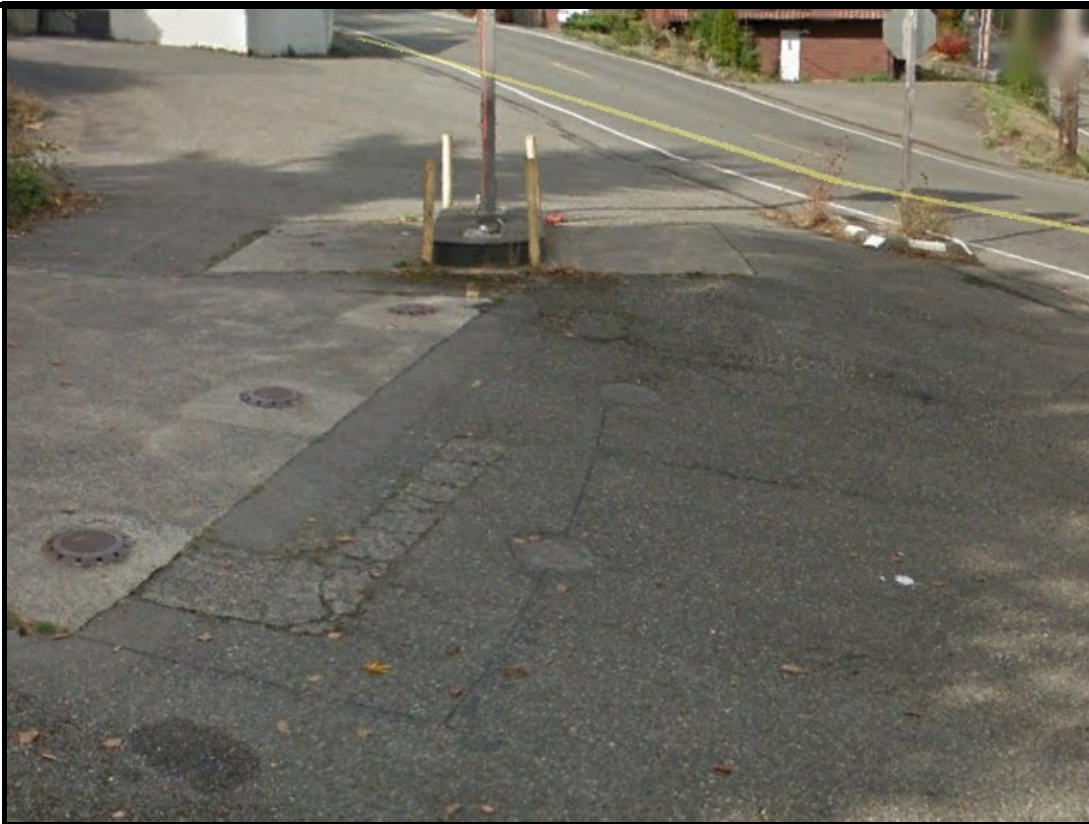
4

**Description:** Looking north at the UST fill ports and former pump island.

**Comments:** Approximate area of confirmed contamination on eastern portion of Property.

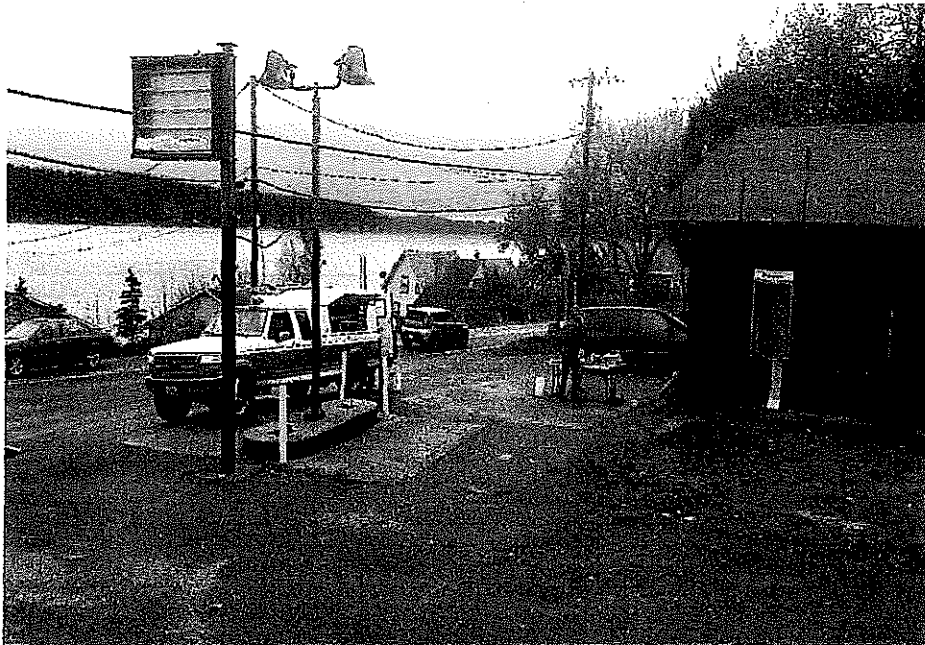
Looking south at the former fueling/dispenser location. Sampling table set up on UST pit area.

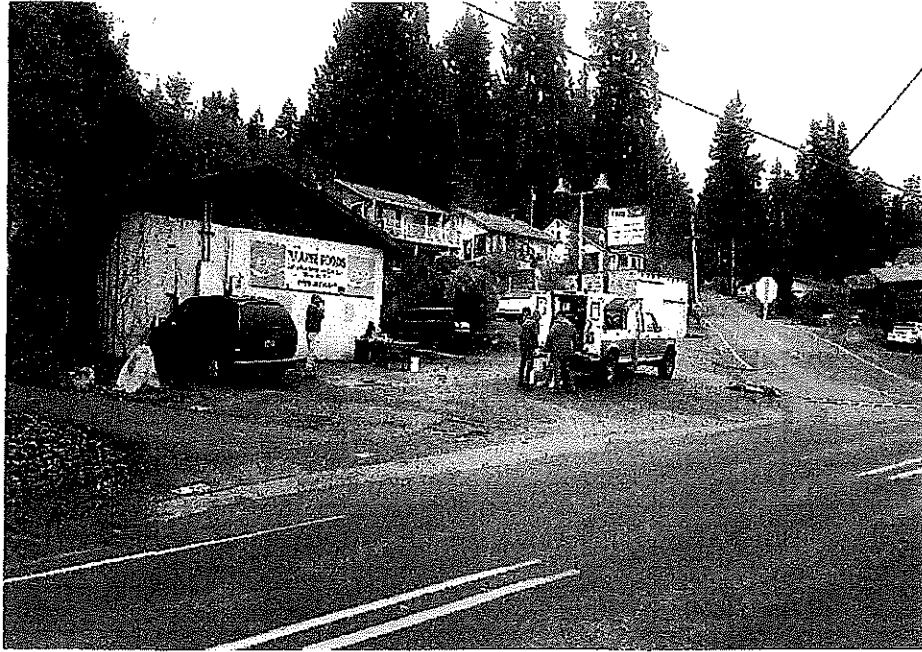
Looking north at boring location B-4, down gradient from UST pit area.
